GASOLINE CONTAMINATION OF PRIVATE WELL WATER SUPPLY

TOWNSHIP OF REAR OF LEEDS AND LANSDOWNE
COMMUNITY OF LYNDHURST

Prepared by:
F. R. Campbell
Hydrology and Monitoring Section
Water Resources Branch
Ministry of the Environment
May 1974

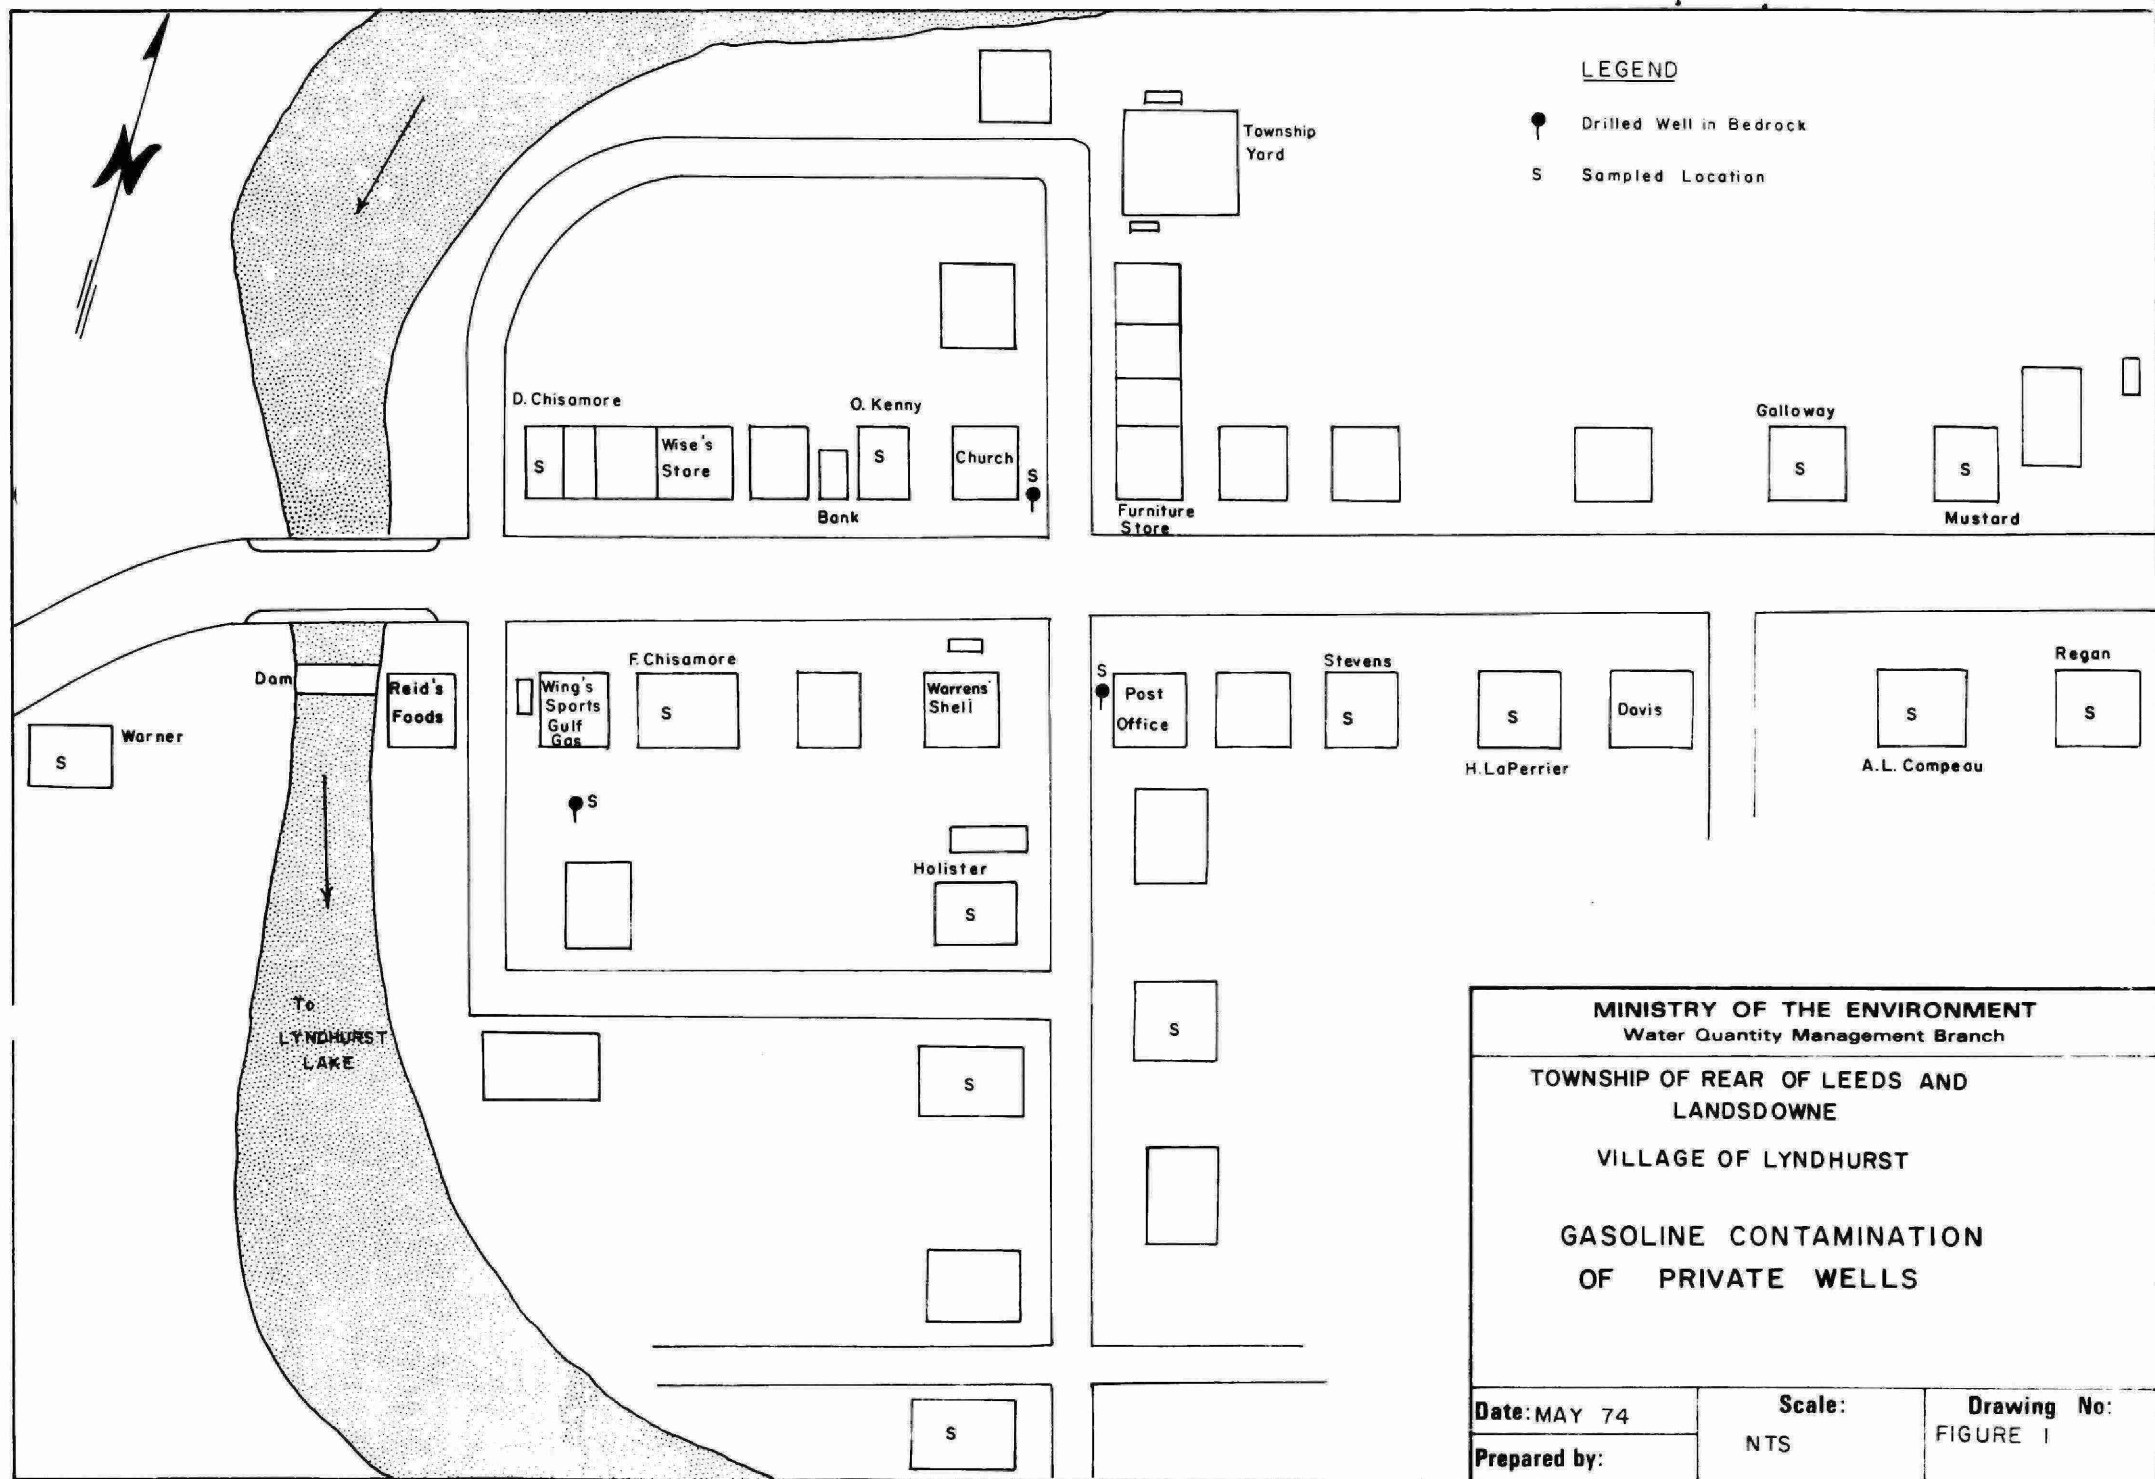
At the request of Mr. G. Macey, Industrial Waste Branch, Kingston, an investigation was conducted by the Water Quantity Management Branch in the Community of Lyndhurst, to determine the cause of gasoline contamination of the Chisamore and Post Office well-water supplies, shown in Figure 1.

The study included an office examination of water-well records on file for the area and a review of pertinent literature. Field work consisted of an examination of geologic and topographic features, the collection of well-water samples for chemical analyses and interviews with local residents. Well locations and sampling locations are shown in Figure 1.

There are three known possible sources of fresh gasoline, a Shell gasoline station, a Gulf gasoline station and a gasoline storage tank at the Township Yard, the locations of which are shown in Figure 1.
